Effects of irrigation performance on water balance: Krueng Baro Irrigation Scheme (Aceh-Indonesia) as a case study

For citation: Azmeri A., Yulianur A., Zahrati U., Faudli I. 2019. Effects of irrigation performance on water balance: Krueng Baro Irrigation Scheme (Aceh-Indonesia) as a case study. *Journal of Water and Land Development*. No. 42 (VII–IX) p. 12–20. DOI: 10.2478/jwld-2019-0040.

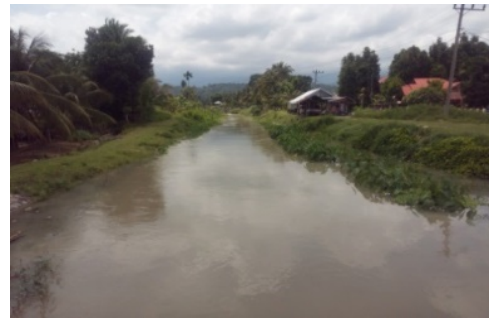
Photo 1. The condition of the structure, the primary channels of Baro Kanan (phot. A. Azmeri)

In Photo 1 the sediments of soil and the weeds on the edge of the stone masonry lining channels.

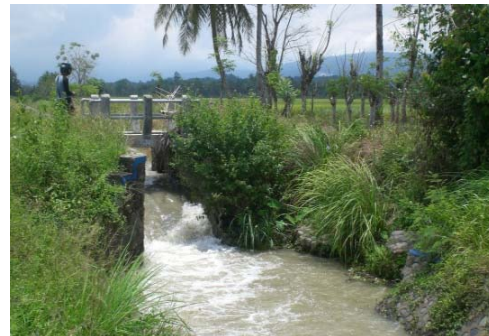
Photo 2. The condition of the structure, the primary channels of Baro Kiri (phot. A. Azmeri)

In Photo 2 the landslide and damage of the protection in the downstream waterfall.

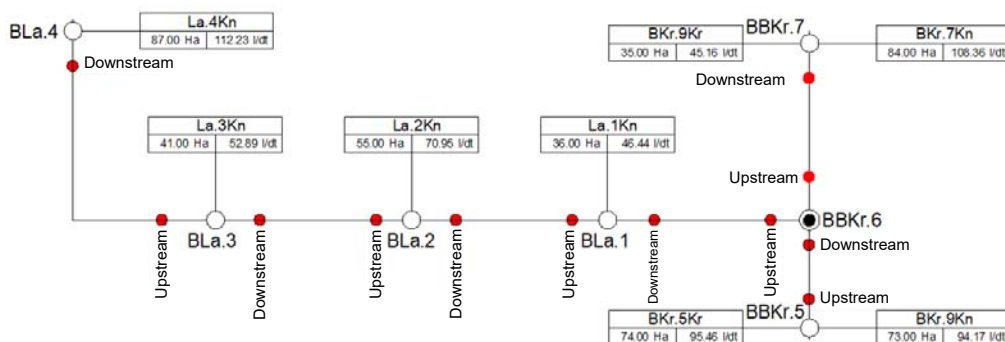
Fig. 3. Scheme of determining the sample points for each channel segment; source: own study

The hydraulic characteristics measured the velocity of distribution and discharge passing along the cross section at the beginning and the end of each irrigation channel. The diagram of determining the sample points for each channel segment is provided in Figure 3.

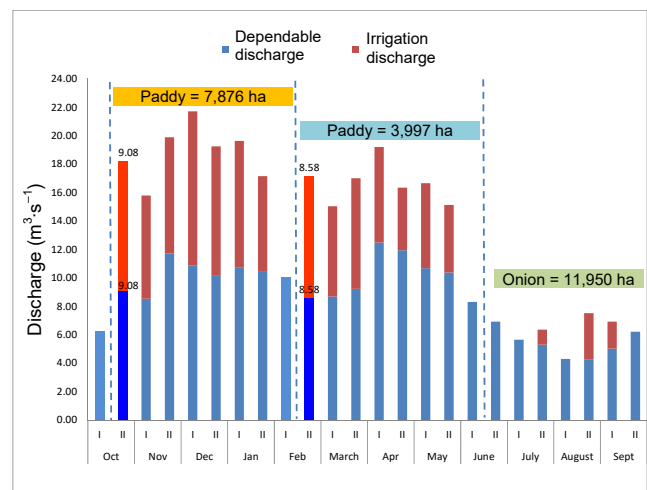
Fig. 4. The optimized pattern of water balance; source: own study

Based on the operating pattern of the existing weir, the water supply began in October II. Based on the water balance optimization (Fig. 4), the irrigable areas in planting season I, II and III were 7,876 ha (paddy), 3,997 ha (paddy), and 11,950 ha (onion) respectively. The area of irrigated land was decreased in planting season I and II due to the decrease in the actual conveyance efficiency. The dependable water discharge was limited in the planting season I, at the beginning of planting (Oct II), also in the second planting season (Febr II). However, throughout other time of the year, the water was sufficient. Water shortage
