Numerical analysis of stream renovation using MIKE 11-GIS and HEC-RAS5

For citation: Nazari Giglou A. 2021. Numerical analysis of stream renovation using MIKE 11-GIS and HEC-RAS5. *Journal of Water and Land Development*. No. 48 (I–III) p. 22–31. DOI 10.24425/jwld.2021.136143.

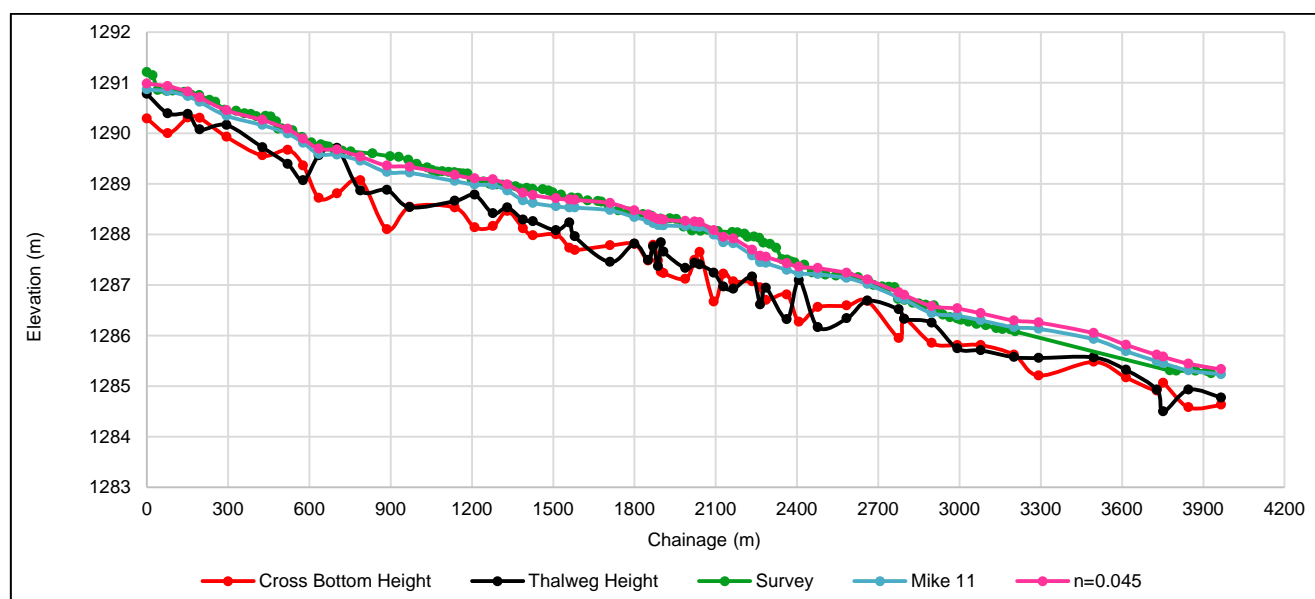
Fig. 4. Model comparison; source: own study

There is no generally admissible criterion by which a model can be considered plausible. This consideration closely depends on the model’s application. Therefore, the hysteresis argument of model evaluation is comparatively general. After developing MIKE 11 for the Red River, the issues needed to be evaluated so as to affirm the model’s validity. The virtual test of a model is its capability to predict a system response (gauged data). This test was made by comparison of the gauged data, which was evaluated from MIKE 11 with an observed stage hydrograph at the same river reach (Fig. 4).

For this study *RMSE* has been evaluated by 0.5883 m in MIKE 11 and 0.6094 m in HEC-RAS5.

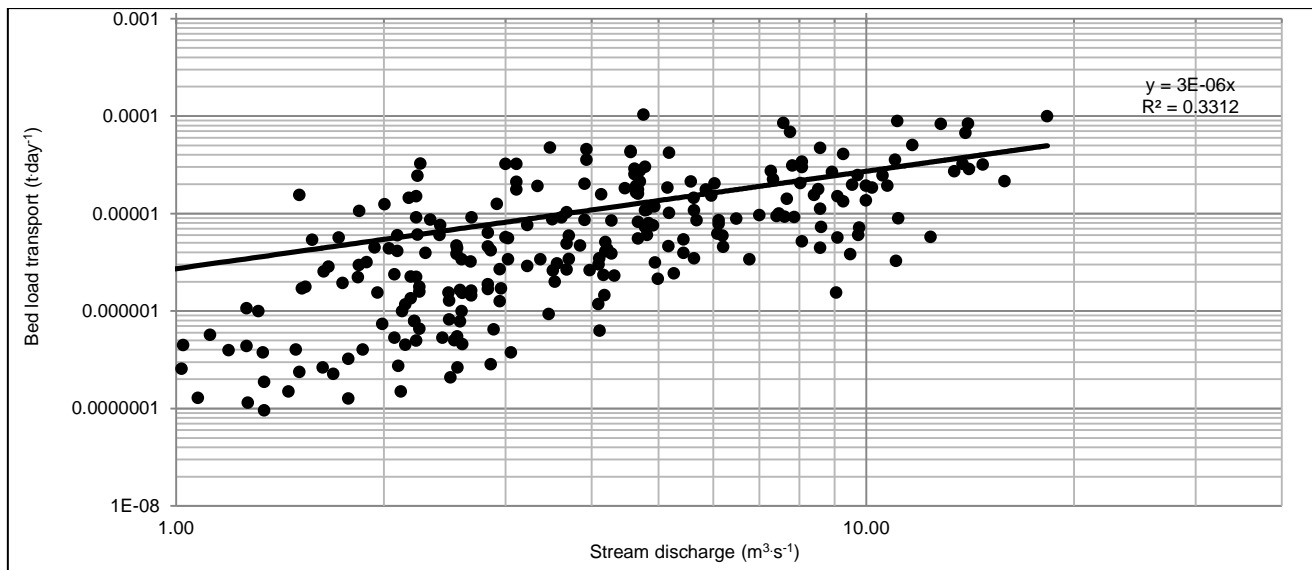
Fig. 5. Bed load calculations for phase I, II, III and IV; source: own study

Since the governing flow-rate is a current reach flow-rate which carries the high potential of sediment during the long period of time, so it is supposed this flow-rate applies the most amount of work in the current reach during must responsible for the current dynamic reach. High flow-rate will spread into the flood-area, because low flow-rates will be hold in the current reach. The daily flow record for the upstream gages has been reconstructed [WHITING 1998], and, for the purposes of this analysis, the 33-year flow record from 1986–2014 at the RRWMA was obtained by summing the flows at the upstream gauging stations. In this research sediment analysis using MIKE 11-GIS is based on these data. Sediment transport predictors for bed load sediment were obtained from linear regression relation of observed values (Fig. 5).

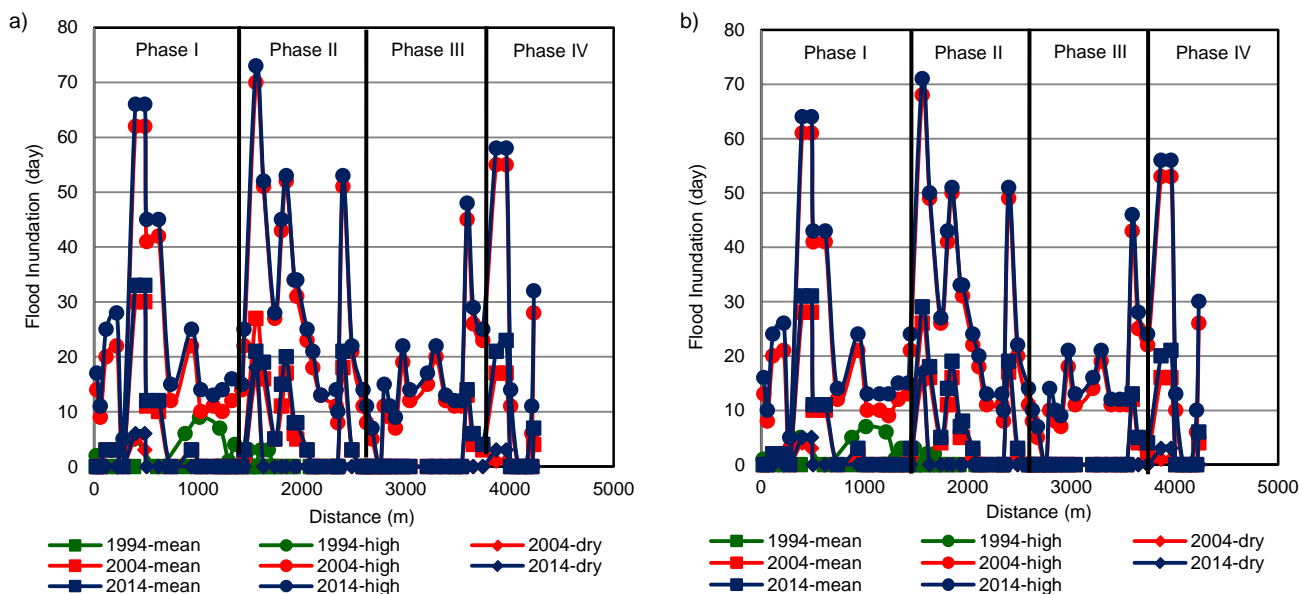
Fig. 7. Flood inundation for dry, mean and high flow period acc. to two models: a) MIKE 11-GIS, b) HEC-RAS5; source: own study

flood conditions. It is determined that this was unacceptable, and this meander was eliminated from the design of phase II and IV. The hydrodynamic modelling has shown, Figure 7, that the remainder of the phase I, II, III and IV design will not alter the flood characteristics downstream, due primarily to steep channel and floodplain slopes in the lower reaches of the meadow.

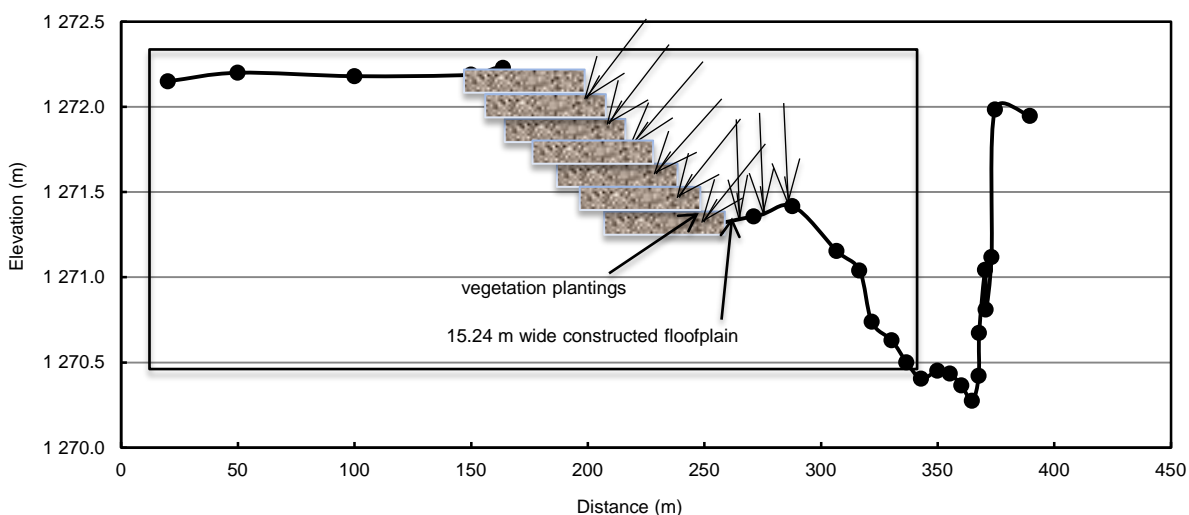
Fig. 9. Typical bank stabilization treatment; source: own study

for riparian vegetation along this 198.12 m reach of the channel (Fig. 9).

The bank will be recontoured to create a floodplain bench on the outside of the meander, and the bank will be stabilized using a bio-stabilization treatment. The excavation will be above the level of the existing clay layer. Figure 9 depicts a typical bank stabilization treatment that consists of building a floodplain approximately 15.240 m wide on the outside of the meander at the same level as the floodplain on the inside of the meander. At the outside edge of the floodplain, the bank is resloped to a 3H:1V slope and reinforced with terraced wraps of coir erosion control fabric around dirt fill. The fabric is designed to degrade after several years which allows the vegetation time to establish and protect the bank naturally with its deep, binding root mass.
