Restoration of ponds in the municipal park in Zduńska Wola, Poland

For citation: Widelska E., Walczak W. 2020. Restoration of ponds in the municipal park in Zduńska Wola, Poland. *Journal of Water and Land Development*. No. 44 (I-III) p. 151-157. DOI: 10.24425/jwld.2019.127056.

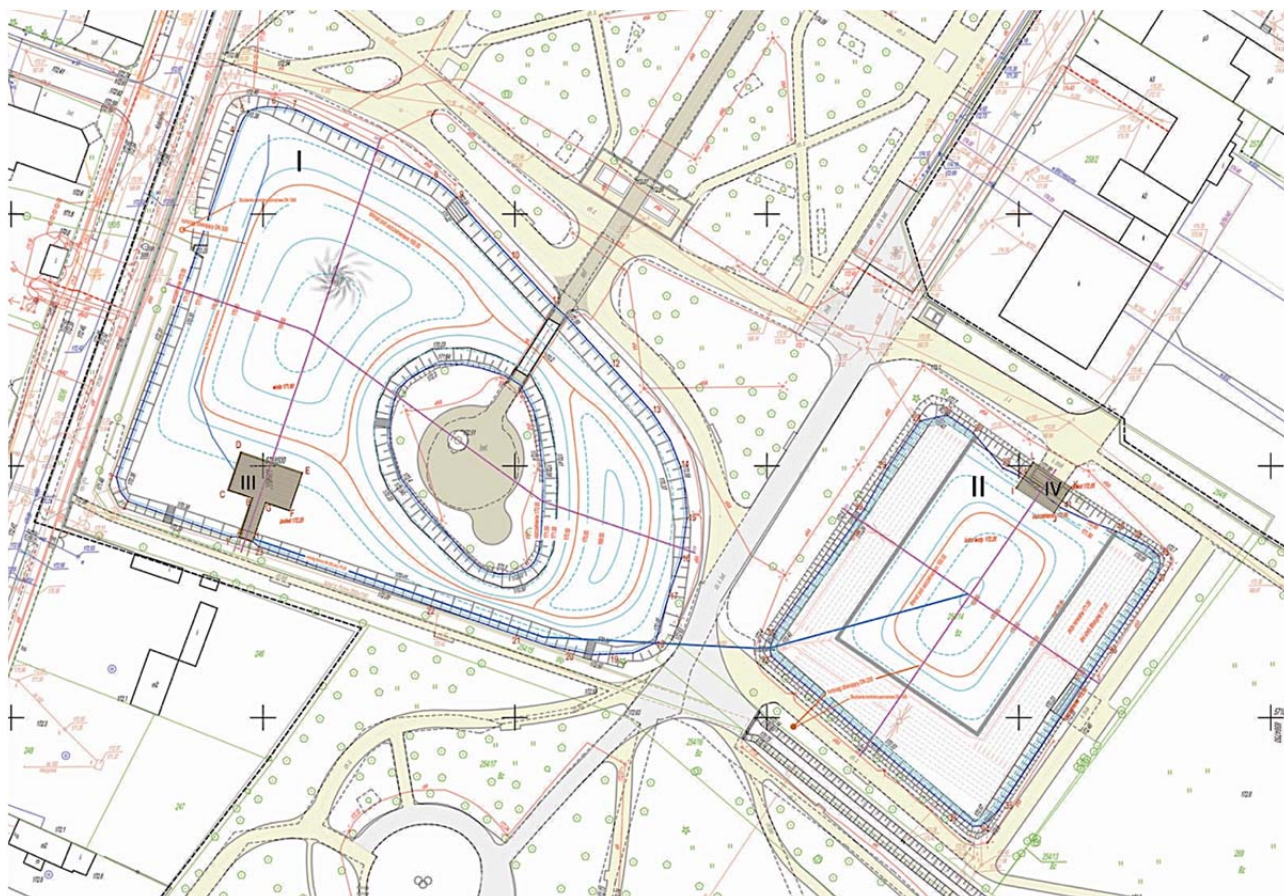
Fig. 1. Fragment of the park restoration project including solutions for the renaturalization of the water system; I = observation and recreation tank, II = regeneration tank (mineral-plant filter), III = technical bridge with pumping station and mineral filters, IV = wooden platform; source: own elaboration

The design concept assumed the rebuilding of municipal ponds together with the surrounding area, with particular emphasis on the optimal solution for sealing, filling and maintaining the purity of water in the ponds (Fig. 1). Therefore, in 2015, it was developed detailed design documentation, taking into account a series of processes that promote the natural purification of water in ponds. In spring 2017, the project was started.

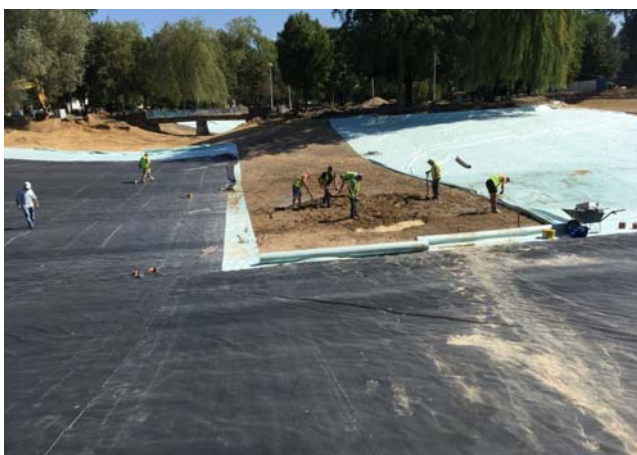
Photo 1. Profiling and sealing the bottom of the recreational reservoir (photo *W. Walczak*)

Surface of the bottom of the pond had to be leveled and thoroughly compacted (larger depressions were buried in layers and compacted), free of sharp objects – stones, glass, etc. Sealing of the pond consisted in spreading 400 g/m² of geotextile. For a proper sealing of the pond, EPDM foil 1.02 mm thick with a certificate of neutrality with respect to flora and fauna in the ponds, was used (Photo 1). In order to maintain the water table at a constant, designed level, it was necessary to permanently stabilize the edges of the pond at the appropriate level (deviations from the level could not be more than 1 cm). The entire bottom of the tanks, including the pond shore (about 1 m wide), was lined with twice washed gravel (16–32 mm fraction) with a 20 cm thick layer.

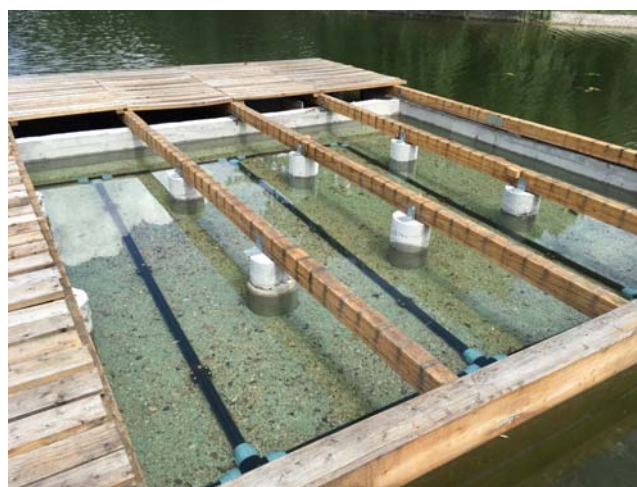
Photo 2. Chamber with mechanical-mineral filter under the platform in recreational pond (photo: *W. Walczak*)

In autumn 2017, tanks were filled with water for the first time after reconstruction. Water quality, when using biologically active sorption filters, depends on the material used, its adsorption properties and intensity of biochemical processes (Photo 2). It is extremely important in the process of effective removal of organic compounds (above all, phosphorus and nitrogen compounds) as well as elements present in trace amounts (e.g. heavy metals) [PRUSS *et al.* 2009]. Therefore, the mineral substrate Biozamonit® (4–16 mm fraction) was used, which is the nitrogen, phosphorus and heavy metals as well as parasites sorbent with the addition of FerroSorp® iron hydroxide (phosphorus absorbent). This trade name includes lime-silica rocks (bedrock), zeolite, dolomite or limestone grits in appropriate proportions [WALCZAK 2015].

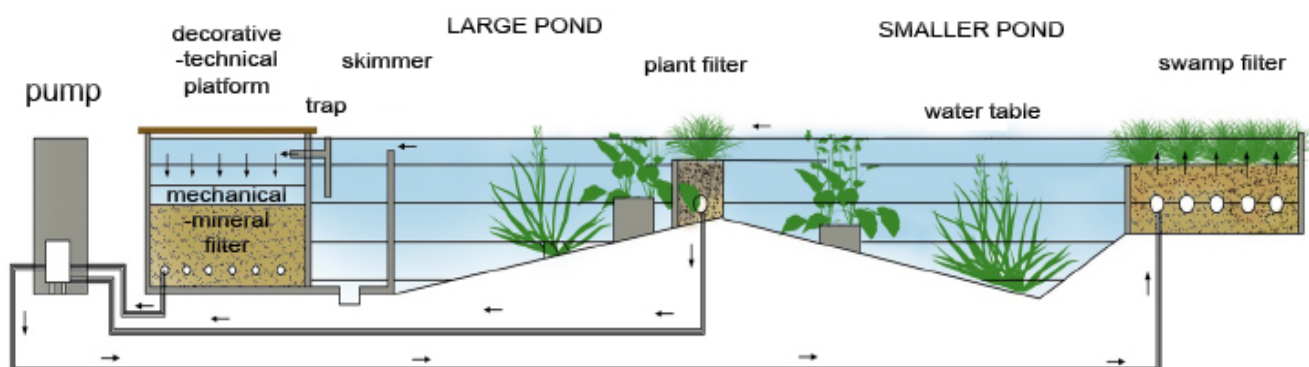
Fig. 2. Diagram of pond water circulation;
source: own elaboration

Purification of water in ponds is based primarily on the proper selection of filtration material (mineral in properly developed proportions adapted to the content of elements in the water supplying the tanks) and forcing water circulation in a closed system, equipped with pumps, overflows, mechanical-mineral filter and relevant from phyto- and rhizo-filtration point of view – swamp filter (mineral bed planted with plants) (Fig. 2).

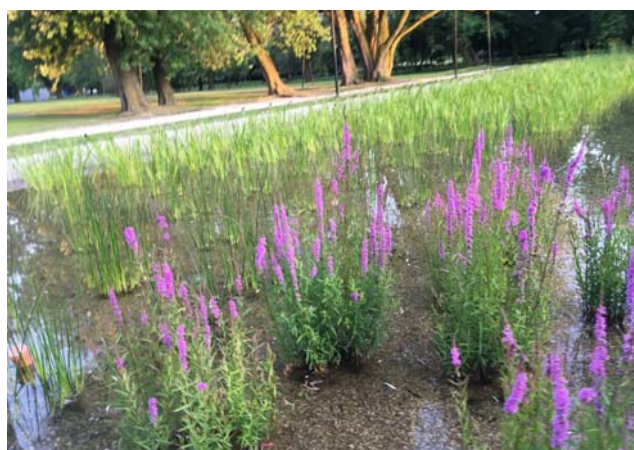
Photo 3. Mineral-plant filter with visible plantings of purple loosestrife, bulrush and calamus (photo: W. Walczak)

Therefore, several habitat zones have been arranged in the pond. In the open water, plants with delicate, flabby stems and fine leaves (adapting their requirements to the depth of the zone) were planted (Photo 3). Waterlily with decorative leaves and flowers were planted in the bottom layer. There are also numerous zooplankton species in this zone, which very effectively support water filtration [SPIEKER 2008]. The banks were planted with iris, calamus and other littoral species, as well as plants from wetland habitats – sedge, horsetail and mint [MILECKA *et al.* 2015]. All species were selected according to the habitat requirements criterion.
